Avoid The Strain!

Recently, we received a customer call saying that a flange on one of our gate valves broke. One of our regional managers was sent to see if he could troubleshoot the issue.

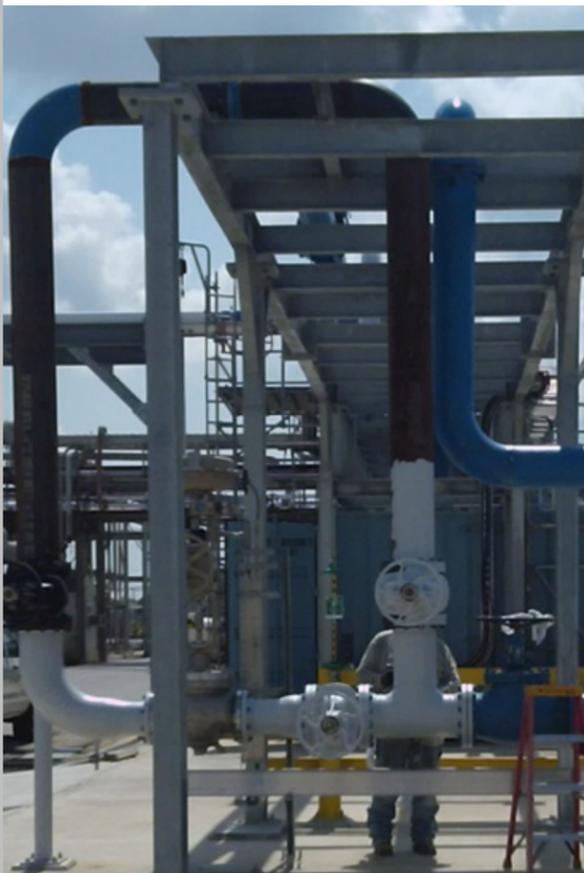
A painting contractor first discovered the crack while applying a protective coating to exposed piping and valves in a new Water Treatment Plant (WTP). The crack was in the casted portion of the valve body that transitions into the connecting flange.

As you can see from the photo, **pipe strain** is the likely culprit. A 10-inch Milwaukee Valve gate is being used as an isolation valve for some inlet bypass piping. The valve alone weighs 436 pounds.

In addition to the broken valve, the system includes two other 400+ lb. gate valves, in addition to two long (more than 15') runs of iron pipe, the related elbows, and the columns of water contained in the piping, all totaling a heck of a load for our cast-iron problem, with little or no visible support to this system. Pipe strain and flange breakage? Obviously!

1. Use proper planning and installation techniques.
2. Never **EVER** use a come-along, chain hoist, or any other tool to force a pipe and valve flange to meet.
3. Piping systems should be designed, not “*spitballed*” at the site.
4. Support your pipes! Valves flange are not designed to support excessive weight.
5. Utilize expansion and bellow joints to minimize effects of temperature and pressure changes.
