# The More You Know

August 19, 2026

## Avoid The Strain!

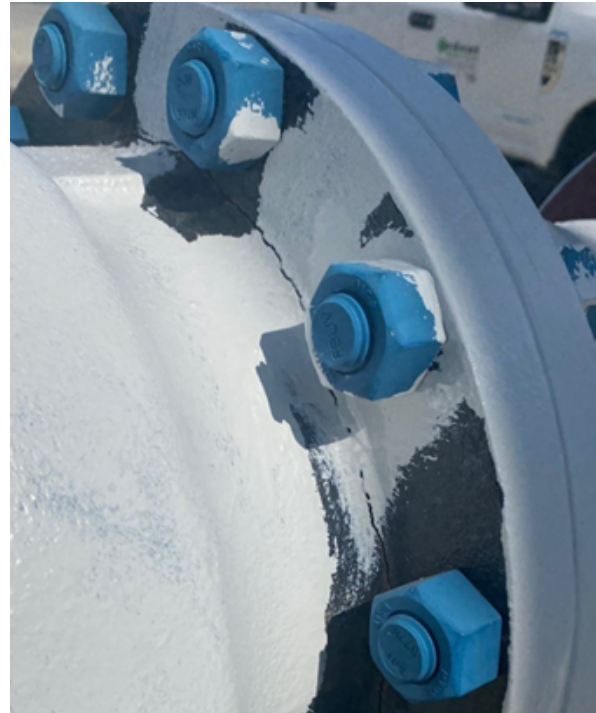
On occasion a customer will call, complaining that a gate valve flange has broken. For instance, a painting contractor discovered this crack while applying a protective coating to exposed piping and valves in a new Water Treatment Plant. The crack was in the casted portion of the valve body that transitions into the connecting flange.

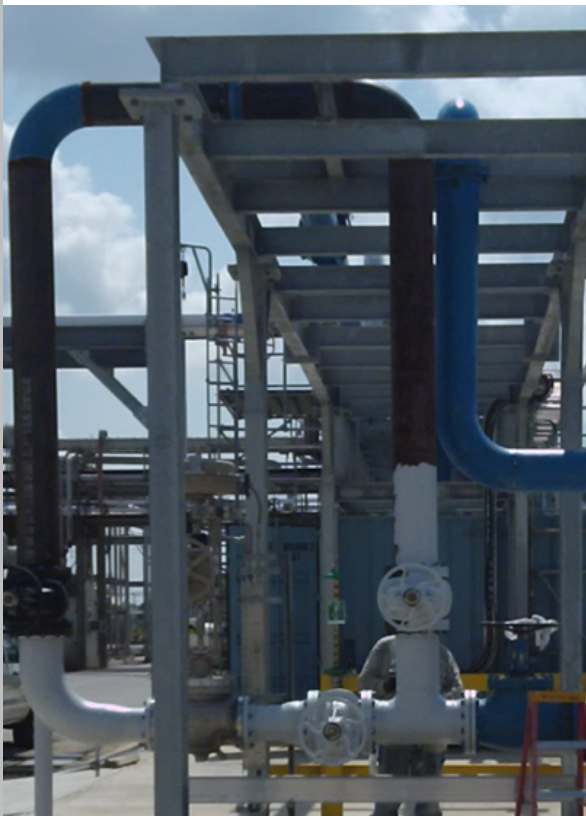
**Pipe Strain** is the likely explanation. A 10-inch Milwaukee Valve gate is being used as an isolation valve for some inlet bypass piping. In this system, the valve alone weighs 436 pounds. The rest of the system includes two other 400+ lb. gate valves, two long (more than 15') runs of iron pipe, the related elbows, and the columns of water contained in the piping. All of this totals a heck of a load for our cast-iron problem, with little or no visible support to this system. Pipe strain and flange breakage? Obviously!

Pipe strain is a leading cause of premature system failure and should be the number one item to correct in your system. Doing so will allow you to get ahead of unplanned failures, downtime, and callbacks.
