The More You Know

D-I-Y Repairs... The Details Matter.

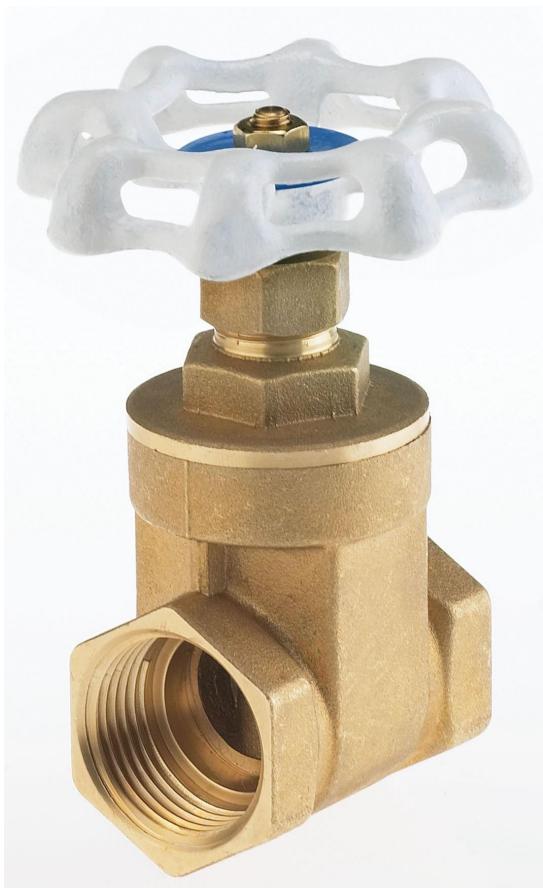
*Milwaukee Valve's 667 valve is a threaded-bonnet gate. It is **NOT** field repairable.*

Due to their low cost, the bulk of these valves are brass or low-lead brass alloys today. Milwaukee Valve does not stock or provide spare parts for these valves. Especially when the valve is soldered into place, the next question becomes, can the customer buy another complete valve and swap the "guts"? since there's a threaded joint at the body/bonnet. The simple answer is an emphatic "NO!"

To be clear, the threaded body/bonnet joint is simply how the valve is assembled. Nothing more. So if a homeowner insists on swapping parts from new to old valves as their Plan A, they better have their local plumber on speed dial as

Plan B. The threaded joint is NOT the equivalent of a Union joint.

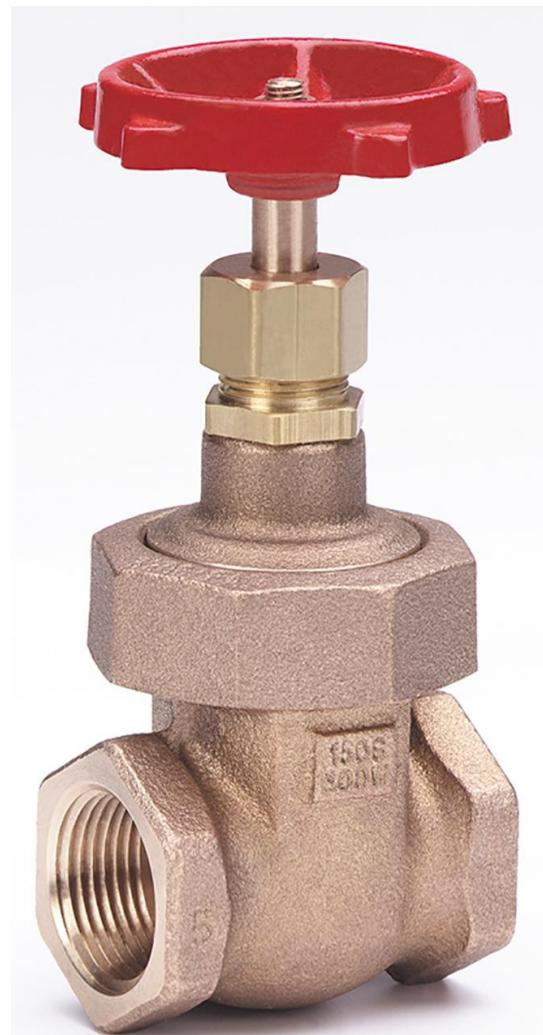
*The 1141 gate is a union-bonnet gate. This valve **CAN BE** repaired in the field.*

Union bonnet valves are designed for this specific purpose. Unlike threaded bonnets, union bonnet styles are made to be serviceable. But please note, removing a union bonnet is no easy task.
