Low-Cost Upgrade Provides Long-Term Reward

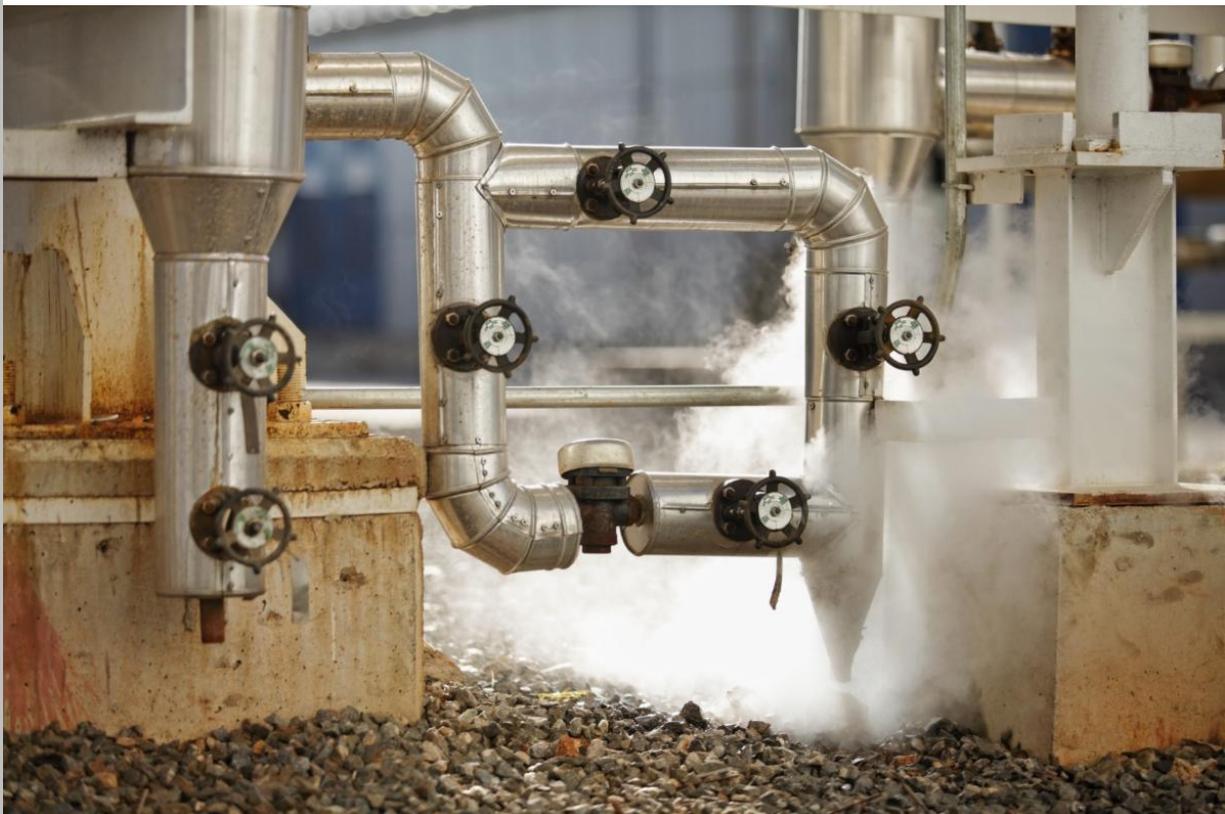
Like all valves, ball valves are rated at a lower pressure for steam service than they are for liquid or gas services. Steam is corrosive and you want to avoid the chance of any pitting or flaking of the chrome plating on the standard brass ball. Steam and steam condensate is generally more corrosive than water because of the presence of dissolved gases, carbon dioxide, and oxygen. These contaminants can result in stem and ball corrosion, unless the valve materials are properly selected. So, when using a ball valve in steam service, choose the stainless steel ball and stem option.

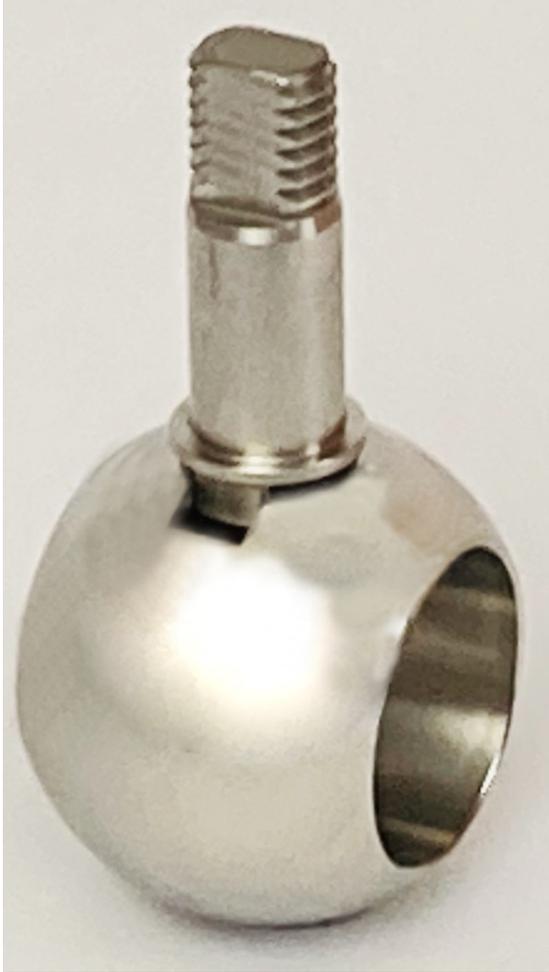
Because stainless is much harder than brass, stainless helps to eliminate the possibility of wear in the ball slot, which can result in “play” in the stem. This is especially evident in actuated ball valves with higher cycle requirements. Stainless steel also provides a much more robust stem and ball engagement, due to the tighter tolerances of the ball slot and the stem in relation to the harder material.
